Star Restoration

Water damage

Encircle
SAMPLE REPORT

Initial Inspection 4-18-2022 BT

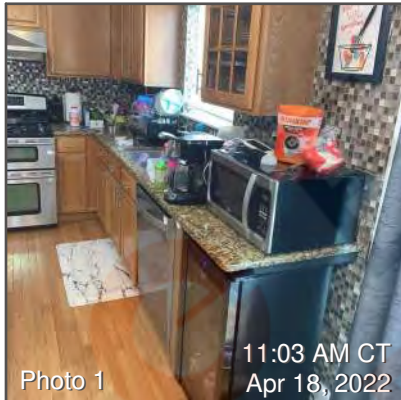
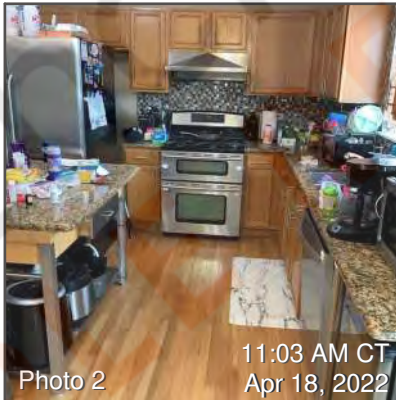
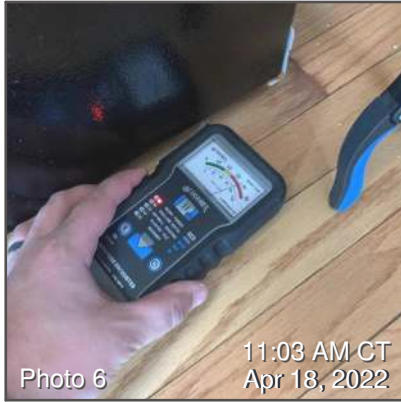
OVERVIEW PHOTOS: Kitchen

Water migrated from the plastic supply line out into the kitchen area for an unknown amount of time. The drywall wall behind the refrigerator and next to the pantry will need to have the base trim removed and walls ventilated to promote proper drying. The toe kick next to the fridge will need to be removed to examine the flooring beneath. The hardwood flooring is extremely cupped and will need to be cut and removed. Once the hardwood flooring is removed we will detail clean and apply a plant-based antimicrobial to the wooden subfloor/install drying equipment.

Detach base trim on impacted drywall (Kitchen)

Inspect the drywall walls for discoloration

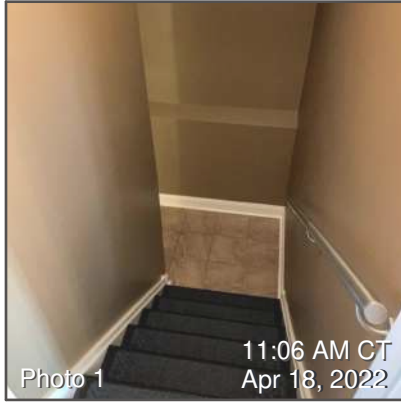
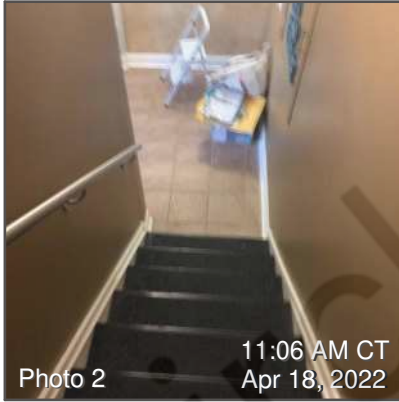
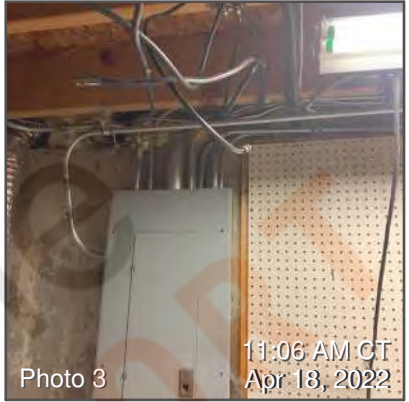
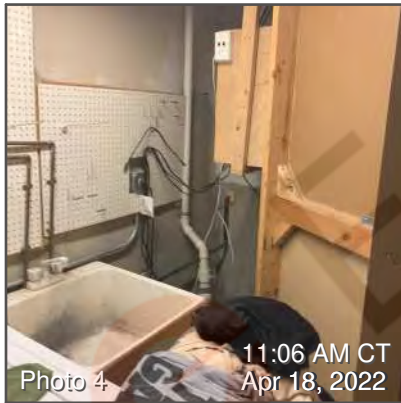
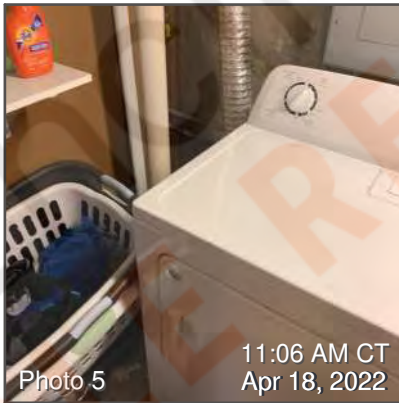
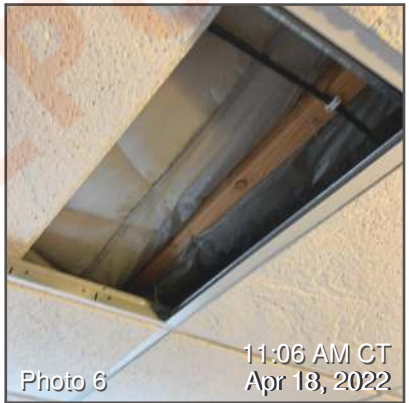
OVERVIEW PHOTOS: Basement

Water continue to migrate through the floor down into the basement. The homeowner noticed water droplets exiting the supply line hole in the laundry room. We will need to further analyze the drop ceiling as the cavity above is completely insulated. We will systematically remove insulation to determine how far the moisture traveled in the ceiling cavity. Once all removals have taken place we will detail clean and apply plant-based antimicrobial.

Remove and save drop ceiling tiles(basement)

Remove and examine the insulation installed in the ceiling cavity (basement)
